CABLE-AGING MANAGEMENT PROGRAM IMPLEMENTATION IN NUCLEAR POWER PLANTS

Marko Pirc [✉], Jurij Avsec¹

Keywords: nuclear cable aging, diagnostic testing criteria, residual life prediction model, risk ranking

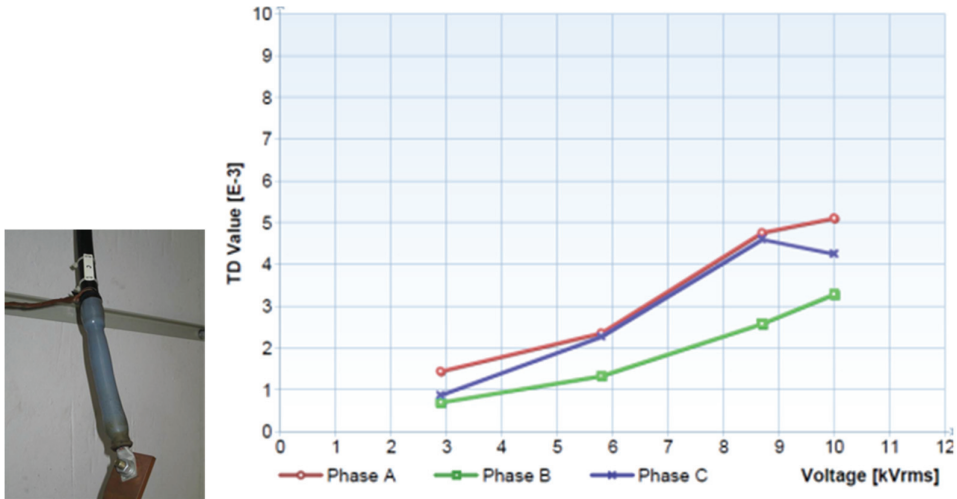
Figure 13: Found deficiency on XLPE cable connection with diagnostic test

Non-qualified Medium voltage (MV) cable N1E with XLPE insulation found bad connection at termination on Figure 13.

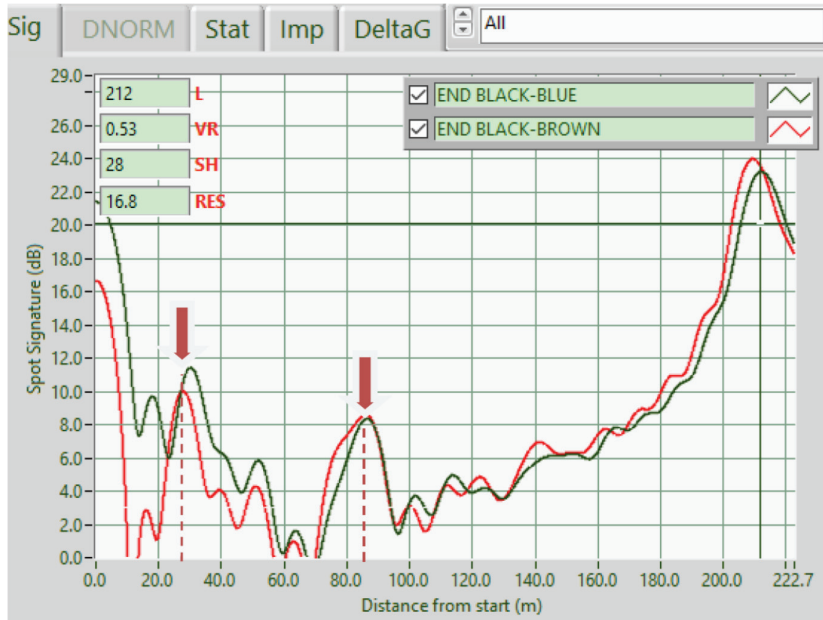
Figure 16: LIRA located two deviations on LV cable insulation, [10]

Line Impedance Resonance Analysis (LIRA) testing of 8 cables resulted in 8 findings and deviations: 3 on field cables and 5 at the instrument testing with the known location of cable damage (short circuit, bad connection, cut in insulation, local burned insulation). In Figure 16, a Spot Signature (dB) is shown with deficiencies at two locations. The short circuit in Figure 11-c) was found 30 m from cable end that is marked in left peak on Figure 16, second was indentation.
